OIL SPILL RESPONSE SERVICES in PERU 2014 – 2016 Projects

**OIL SPILL RESPONSE
SERVICES
in PERU**

REPSOL Km 66 pipeline: *in situ* remediation project

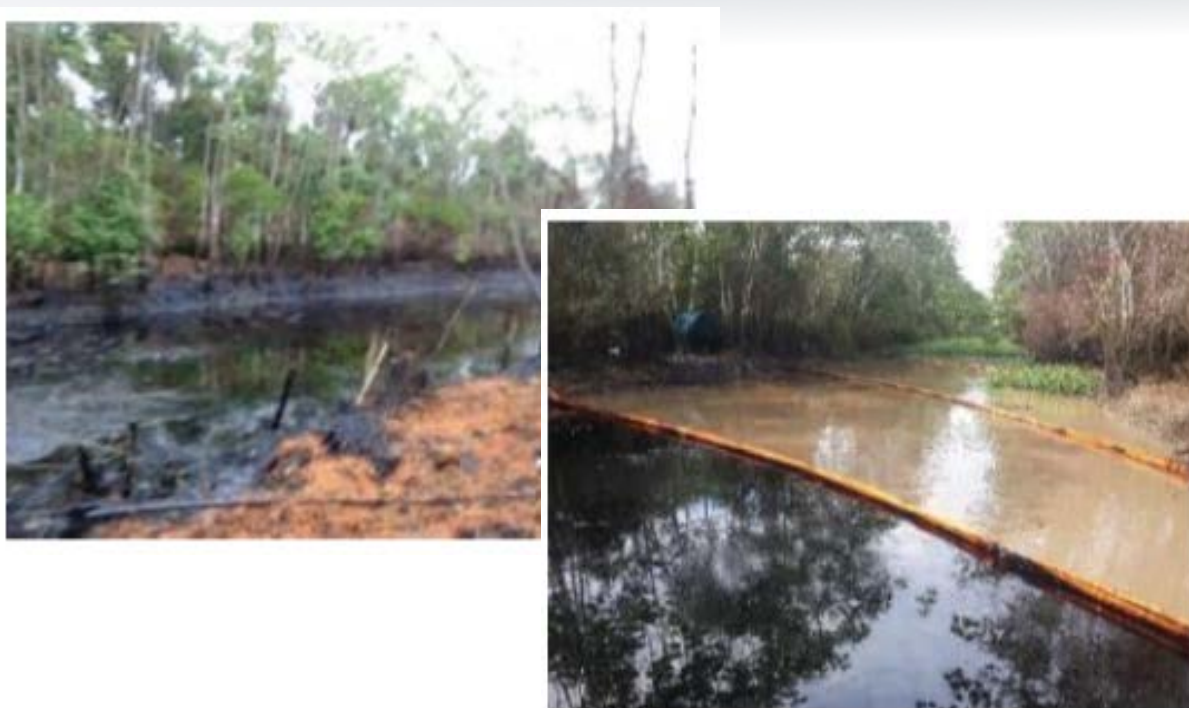
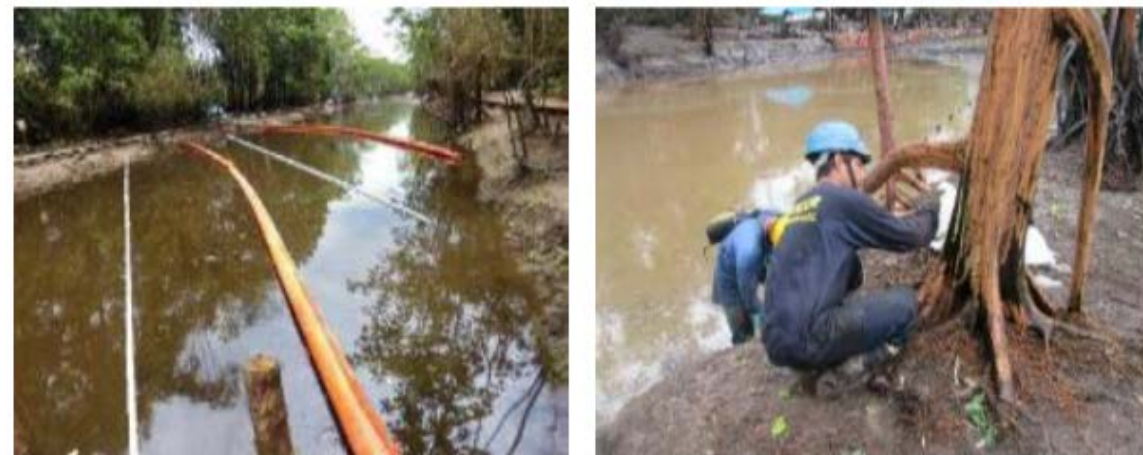
PETROPERU PIPELINE KM 41

Year 2014. Spilled volume: 2.000 Bbls
Time of work: 119 days
Remediated area: 86,500m²
Status: finalized

Specialized equipment: LAMOR skimmers, solid pumps, hot washers, booms

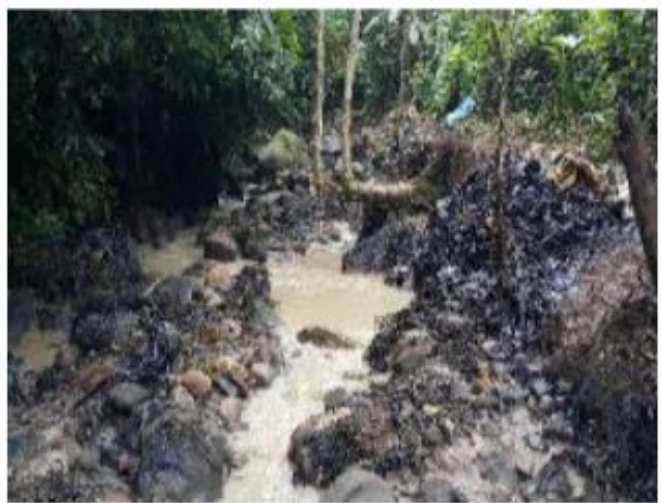
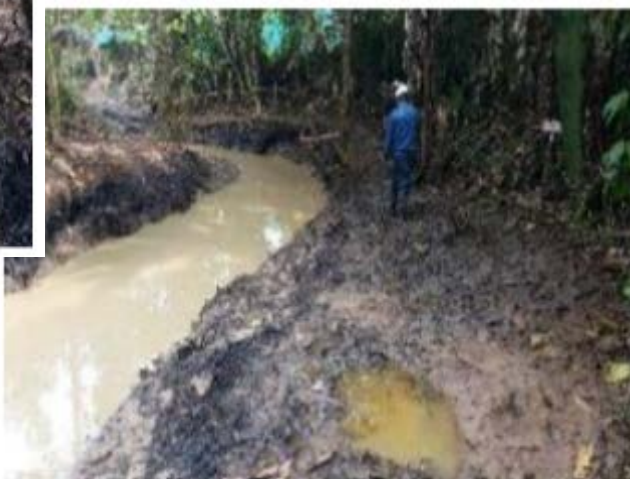
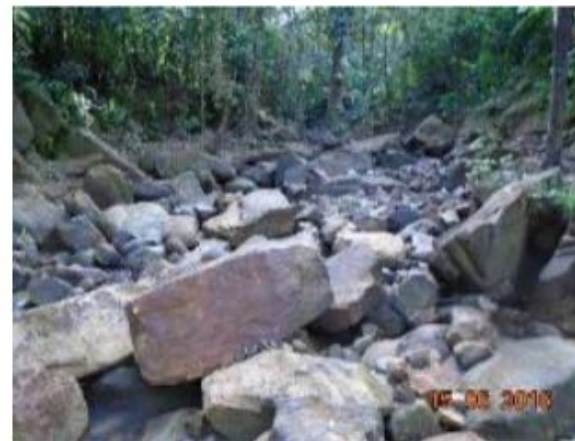
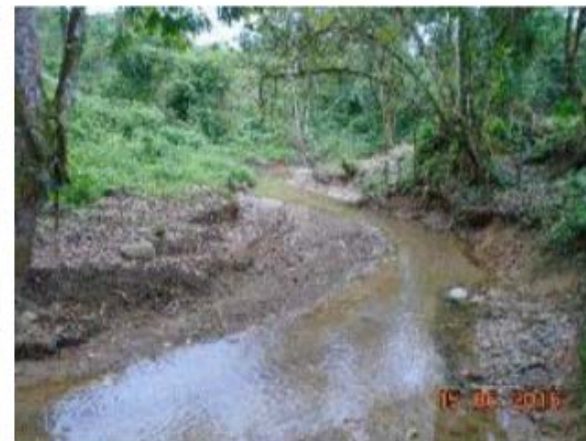
PETROPERU PIPELINE KM 440

Year 2016. Spilled volume: 4.000 Bbls
Time of work: 112 days
Remediated area: 32,500m²
Status: finalized

Specialized equipment: LAMOR skimmers, solid pumps, hot washers, booms

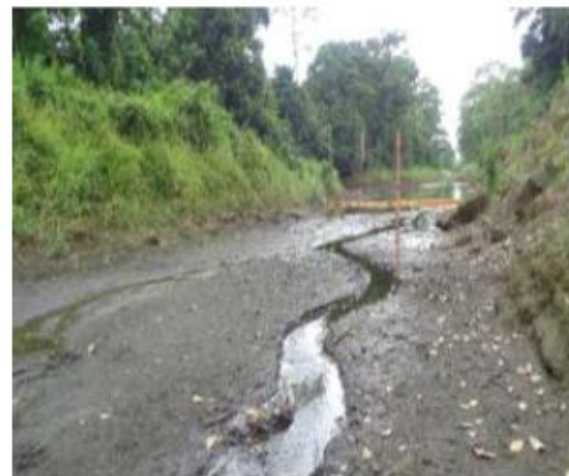
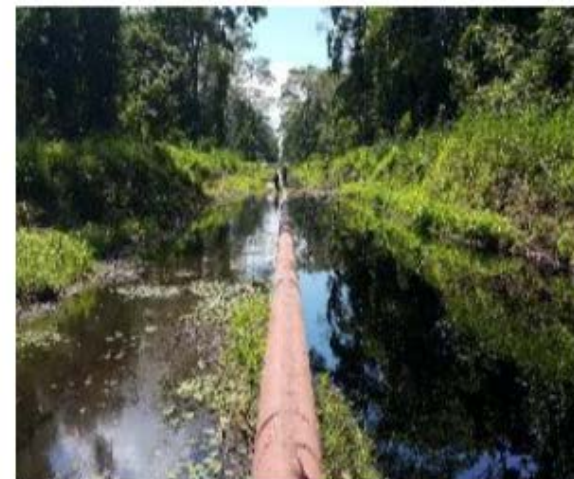
PETROPERU PIPELINE KM 364

Year 2016. Spilled volume: 52000 Gal
Time of work: 40 days
Remediated area: 12.000m²
Status: finalized

Specialized equipment: LAMOR skimmers, solid pumps, hot washers, booms

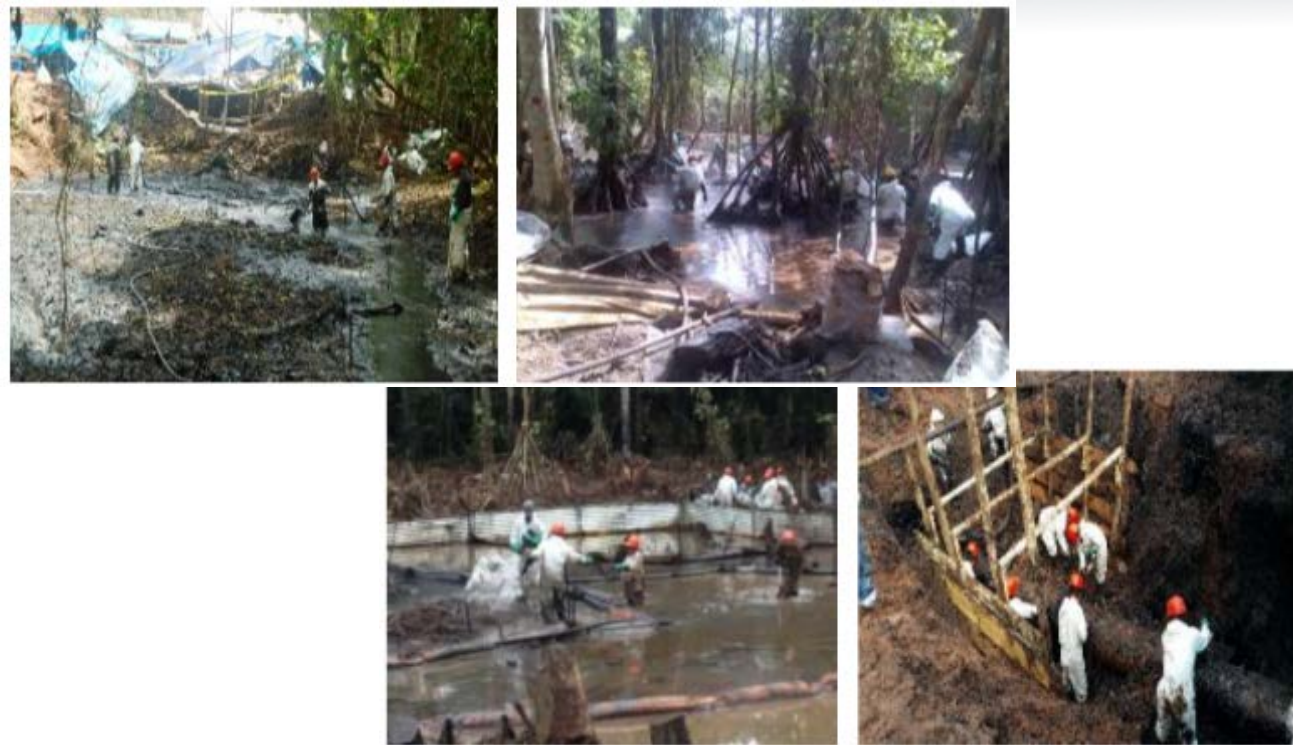
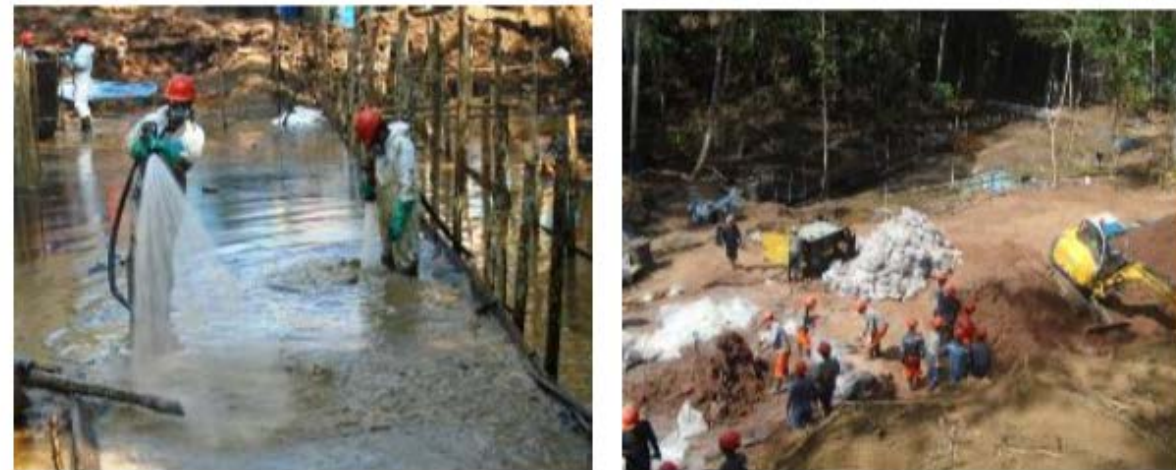
PETROPERU PIPELINE KM 206

Year 2016. Spilled volume: 2.000 Bbls
Time of work: 426 days
Remediated area: 1'240.000m²
Status: in progress

Specialized equipment: LAMOR skimmers, solid pumps, hot washers, booms

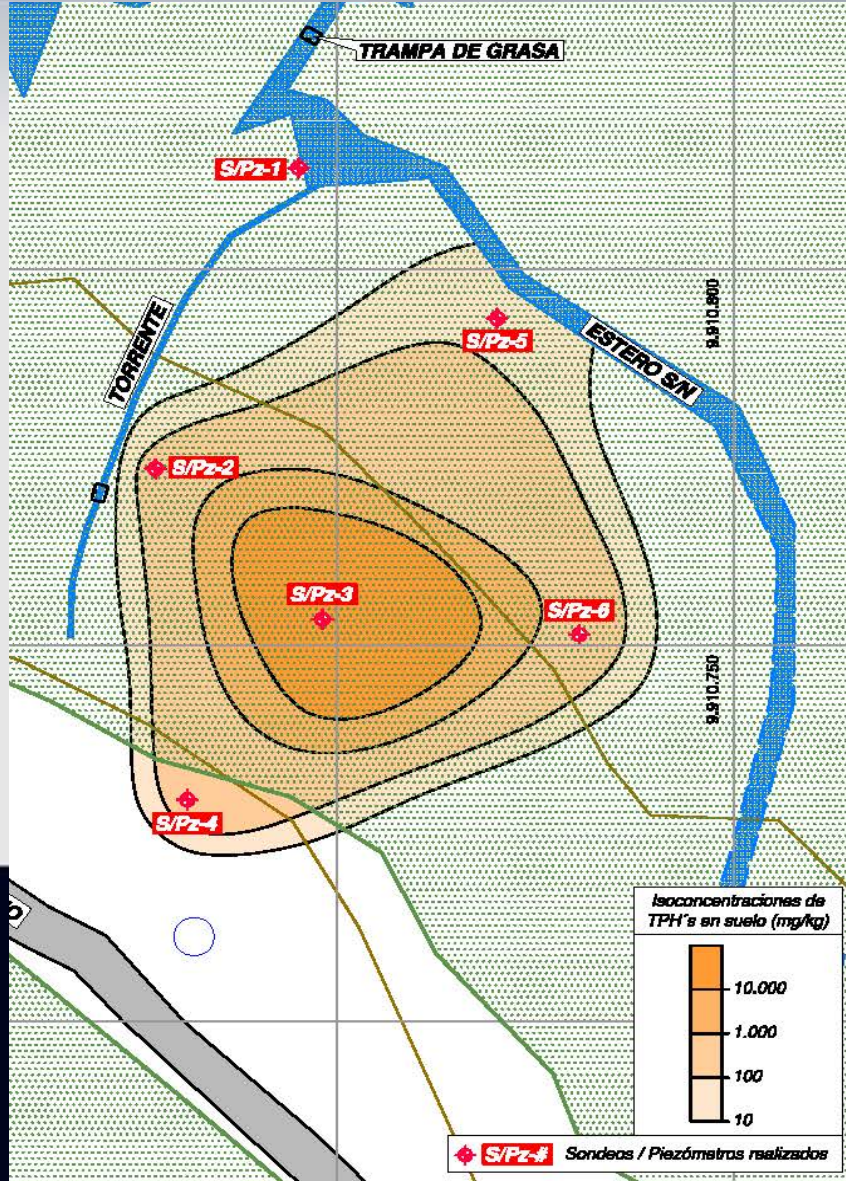
SOIL CONTAMINATION BASE LINE

*Highest
contamination:
13.000 mg/Kg*

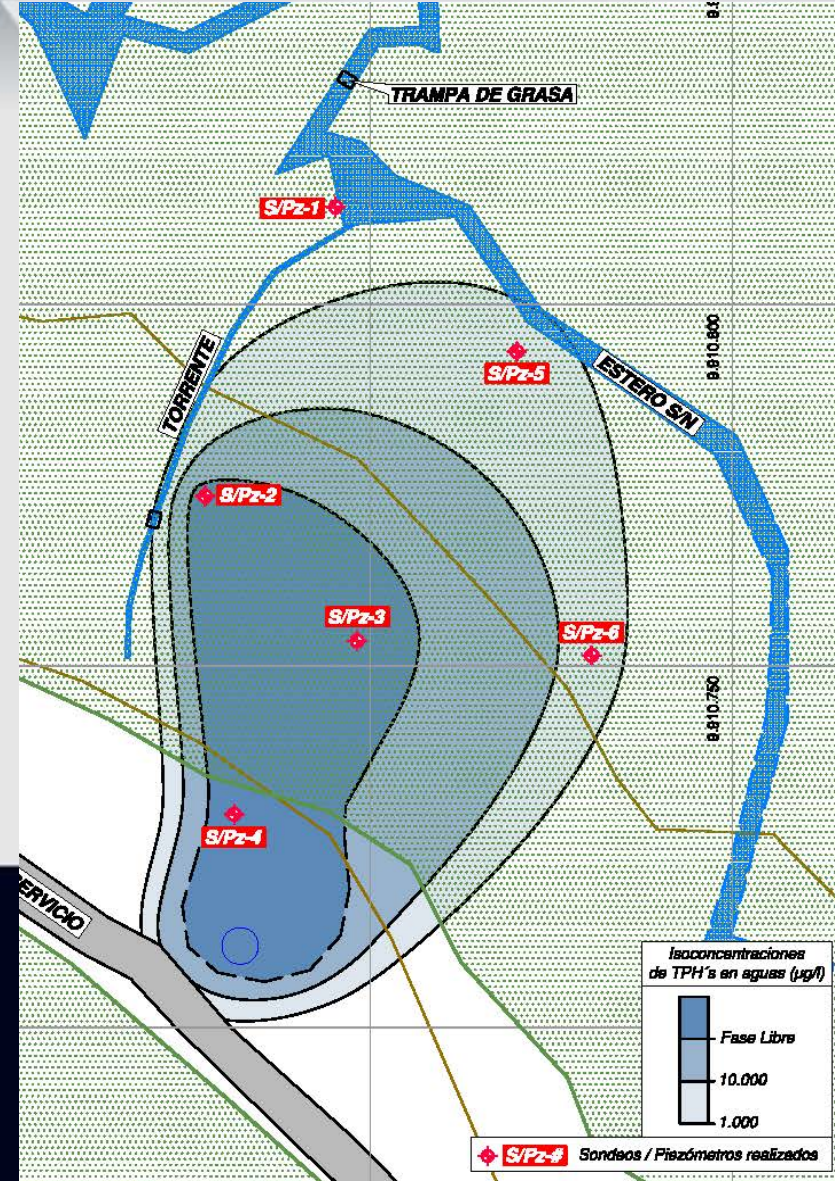
WATER CONTAMINATION BASE LINE

*Highest
contamination:
1.370 mg/mL*

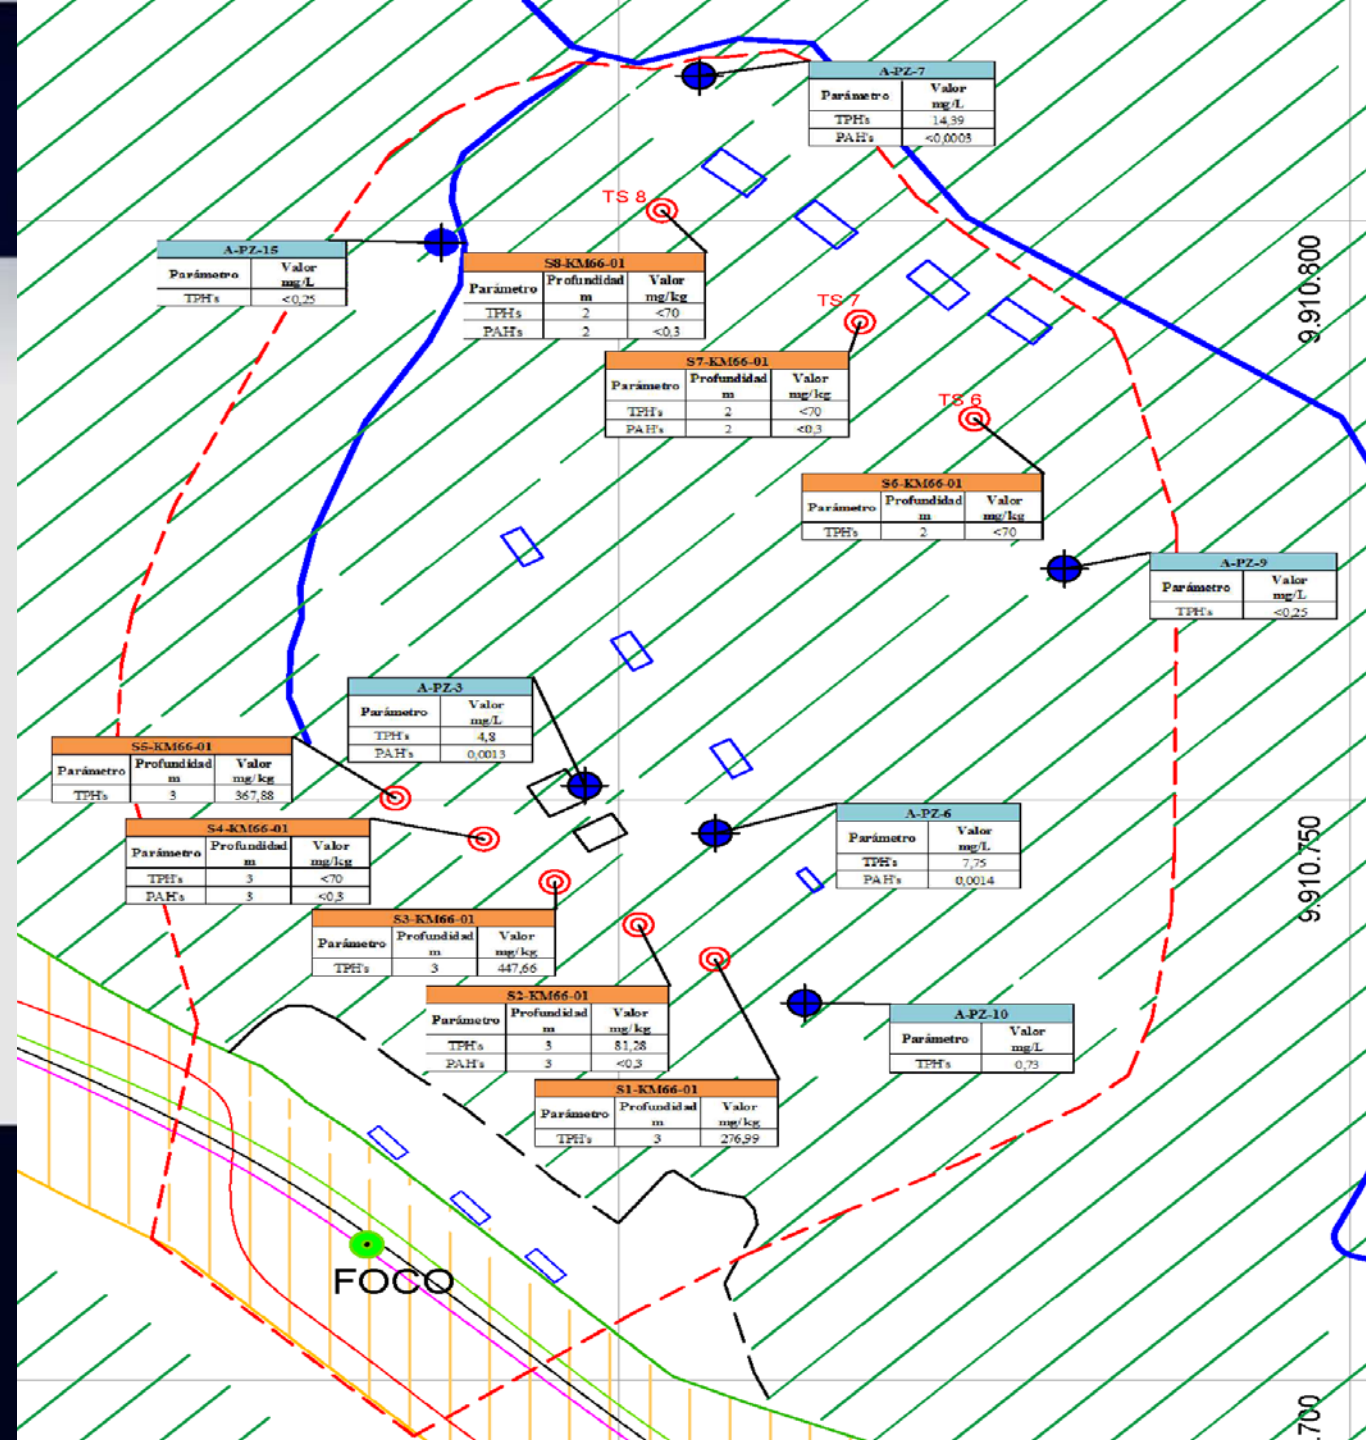
Even though first results show values under the accepted limit (soil 1.000 mg/kg) at 3m of depth, the second sampling tasks (at the end of April 2017) will cover a depth between 3 and 5m to evaluate the behavior of the system. Regarding to water, the target limit is not achieved yet (<20 mg/L), which shows that the remediation process should continue. A 12-month remediation period is estimated.
