OIL SPILL RESPONSE SERVICES in PERU 2014 – 2016 Projects

**OIL SPILL RESPONSE
SERVICES
in PERU**

REPSOL Km 66 pipeline: *in situ* remediation project

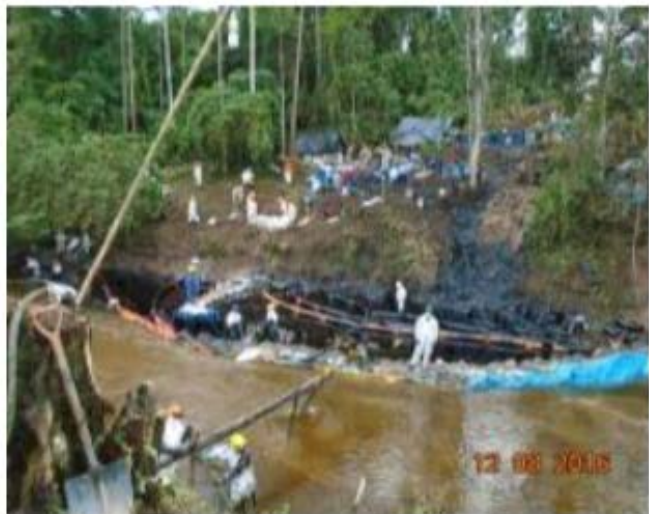
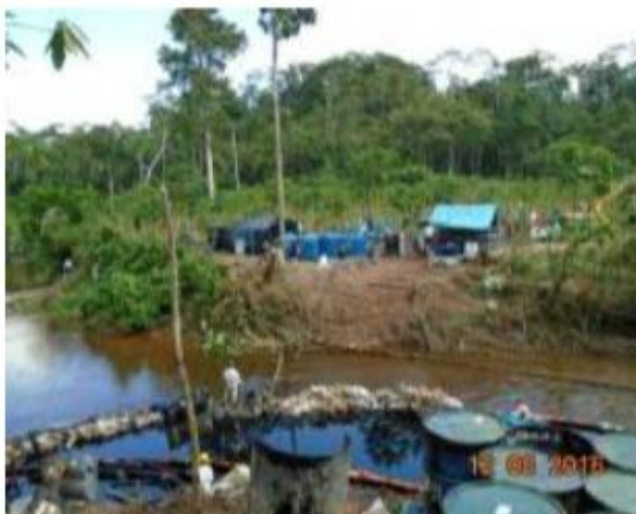
BEFORE

PETROPERU PIPELINE KM 440

Year 2016. Spilled volume: 4.000 Bbls
Time of work: 112 days
Remediated area: 32,500m²
Status: finalized

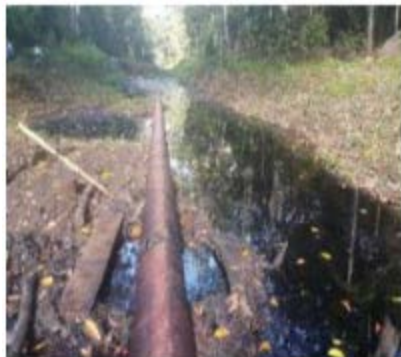
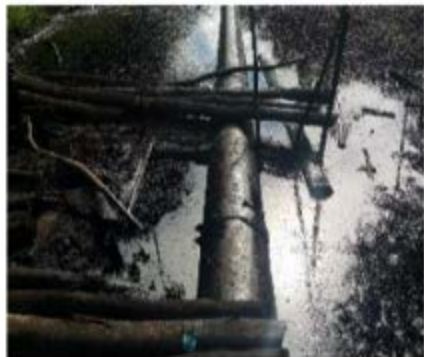
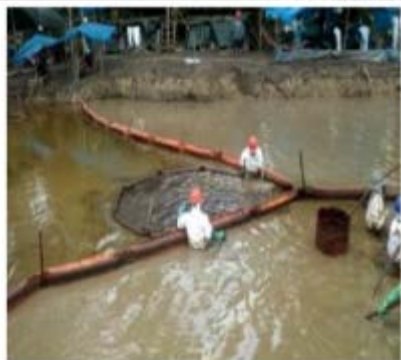
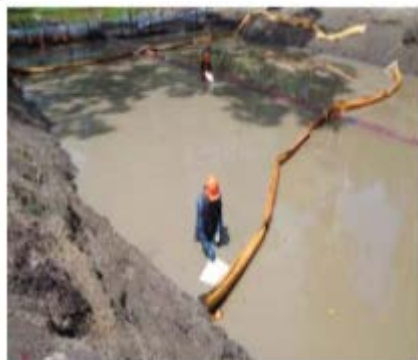
BEFORE

PETROPERU PIPELINE KM 364

Year 2016. Spilled volume: 52000 Gal
Time of work: 40 days
Remediated area: 12.000m²
Status: finalized

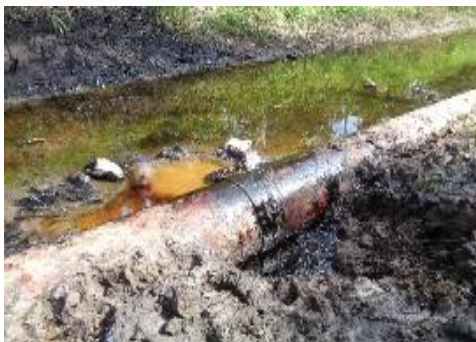
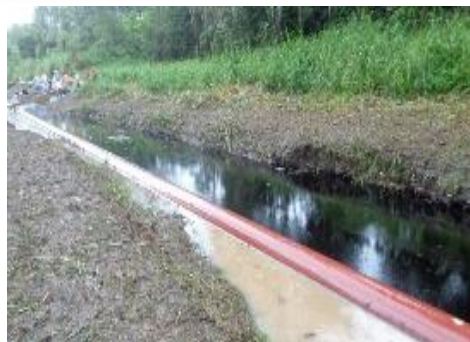
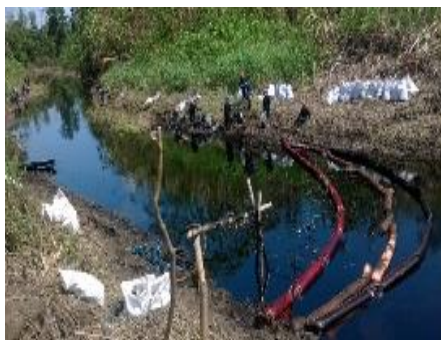
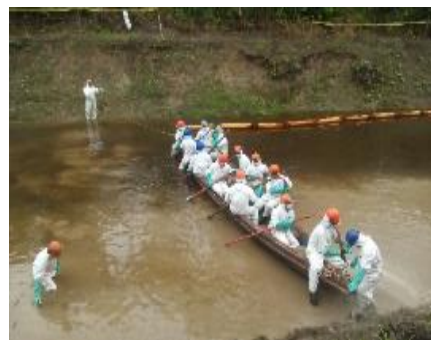
BEFORE

PETROPERU PIPELINE KM 54 & 55

Year 2016.

Remediated area: 41.000m²

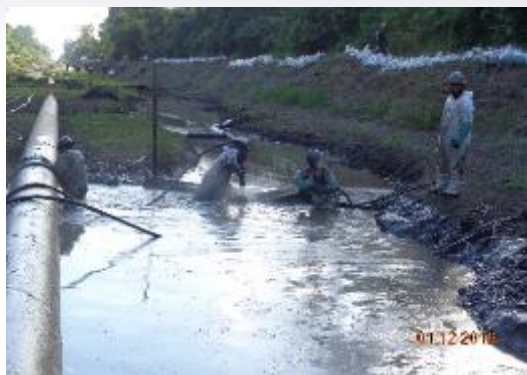
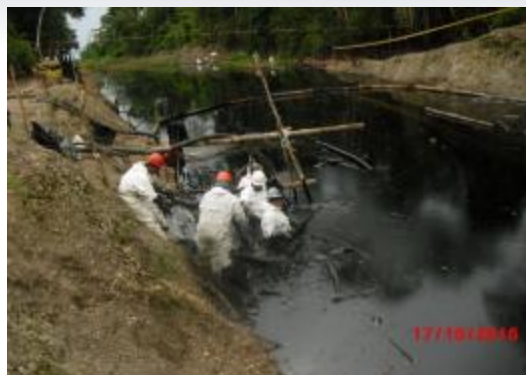
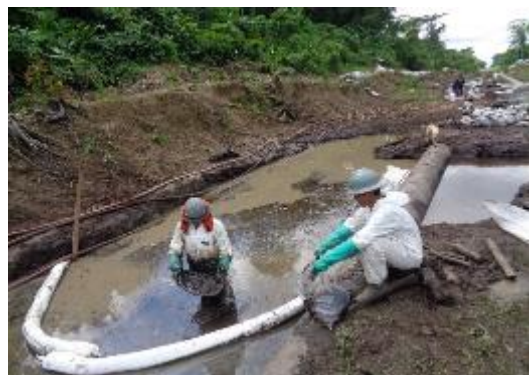
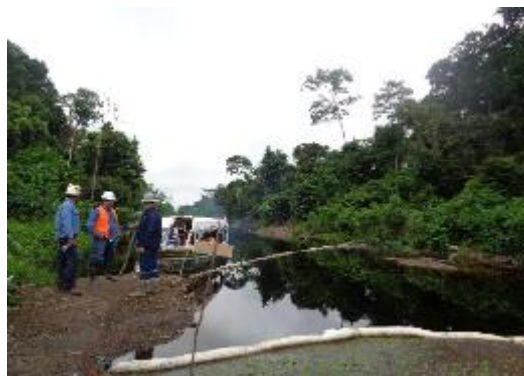
BEFORE

PETROPERU PIPELINE KM 82

Remediated area: 5.500m²

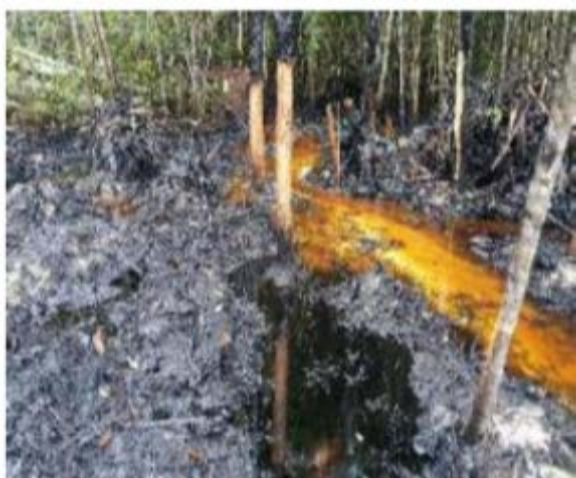
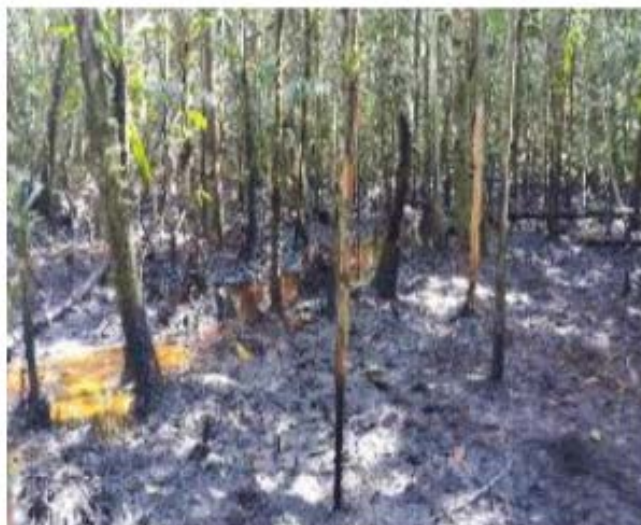
BEFORE

PETROPERU PIPELINE KM 67

Year 2016.
Time of work: 70 days
Remediated area: 9.100m²
Status: finalized

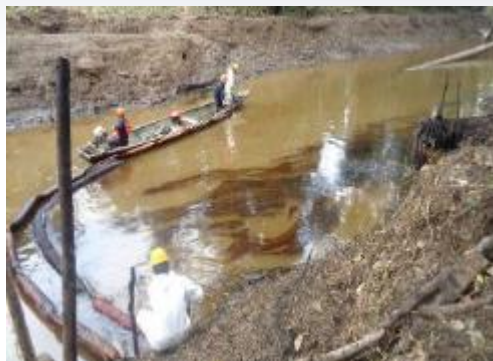
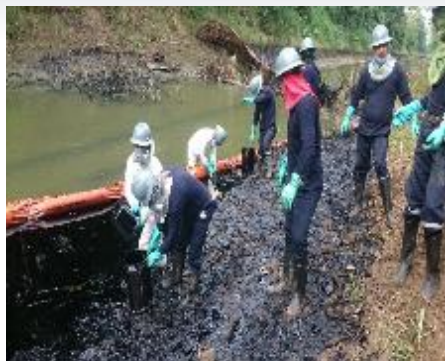
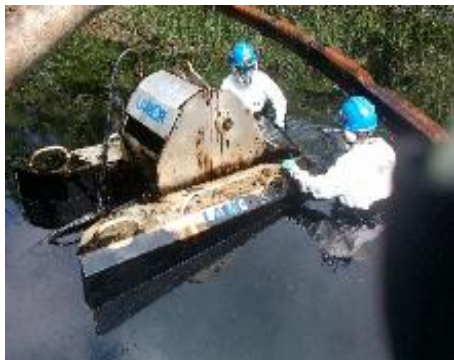
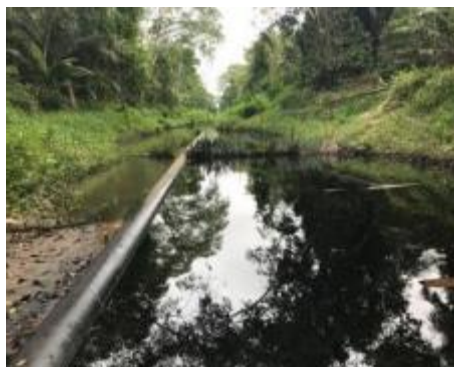
BEFORE

PETROPERU PIPELINE KM 213

Year 2016. Spilled volume: 903 Bbls
